Chapter 1

Purpose And Need

This draft Environmental Impact Statement (EIS) for the Going-to-the-Sun Road documents the analysis of the potential environmental consequences of the alternatives for rehabilitation of the Road. Chapter 1 provides supporting background material,

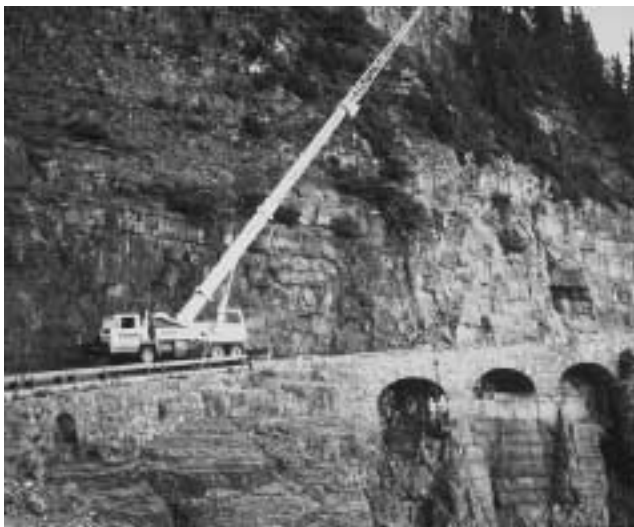
Repair work on Triple arches

Stone retaining walls, primarily between The Loop and Siyeh Bend, are in various states of disrepair (Figure 2). The upper 3 to 8 feet (1 to 2.4 meters) of many of the walls are in distress, with loose or missing stones and crumbling mortar. In some locations, the original retaining walls were replaced with concrete walls and stone-veneer work has not been completed. Stone arch half-bridges have minor to moderate levels of mortar deterioration, except Crystal Point Arch and Triple Arches, which have significant and potentially dangerous deterioration.

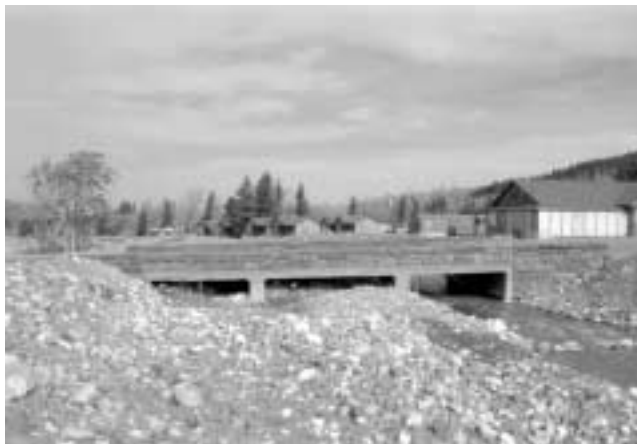
Sediment deposition at Divide Creek Bridge

Several drainages that cross the Road, including Divide Creek, carry high amounts of rock and gravel (Figure 2). The deposition of this material at the bridges restricts flow during large runoff events, which can adversely affect the integrity of the bridge structures and the adjacent roadway. Divide Creek is of particular concern because of the potential for flooding. Previous floods have frequently resulted in impacts to the Road, the historic Divide Creek Bridge, Park residential and maintenance facilities, the St. Mary Visitor Center, and other adjacent lands near the town of St. Mary. The streambed of Divide Creek is at about the same elevation as the floodplain and, as a result, any deposition of material in the streambed encourages the stream to change course into a lower portion of the floodplain and reduces the capacity for flood flow under the bridge (Smillie and Ellerbroek 1991).

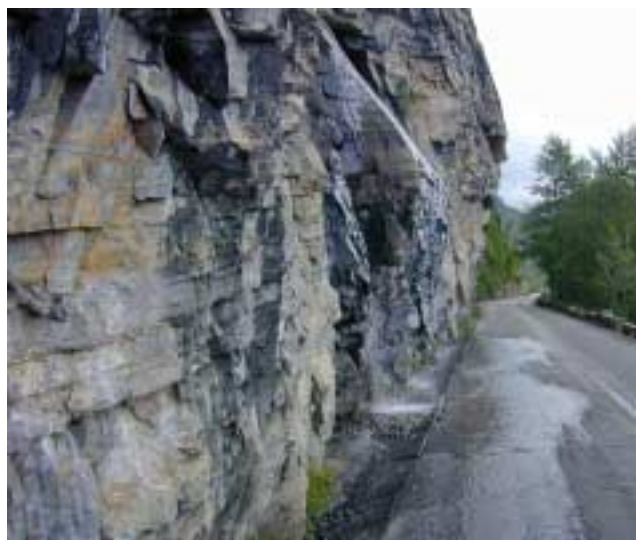
Inadequate roadway drainage

Inadequate drainage from the road surface and subsurface, compounded by malfunctioning drainage structures have contributed to the deterioration of the roadway pavement, road base, retaining walls, guardwalls, and drainage structures and, if not corrected, further significant deterioration would occur. Most of the runoff from melting snow occurs over a short time period in the spring. Narrow and shallow ditches, undersized culverts, and a general

and weakened or failed in some locations due to water intrusion and slumping. In several locations, such as above Crystal Point Arch, drainage flow is trapped against the retaining walls because there is no outlet. This water enters cracks in the asphalt above the wall, undermining the wall. It also results in running or standing water on the roadway, which is a safety hazard for motorists. Erosion of slopes below the Road is occurring from unprotected culvert outlets.

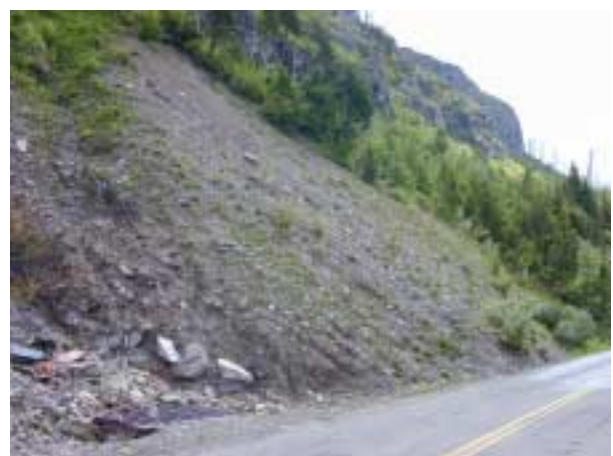
Eroding cut slope

In several locations steep, unstable cut slopes above the Road are actively eroding. This leads to further erosion of the cut slope, loss of soil material, and the loosening of large rocks that roll down the slope onto the roadway. Rockfall hazards are a safety concern throughout much of the steep high elevation portions of the Road between The Loop and Golden Stairs Point (Figure 2). Through natural freeze/thaw processes and erosion, loose rocks periodically break free and land on the roadway. Approximately 70 avalanche chutes are present throughout the high elevation portions of the Road and although not readily controllable, they continue to damage Road guardwalls and other appurtenances. Debris flows along gullies and drainages contribute to Road deterioration from erosion of the roadbase or deposition of materials on the Road.

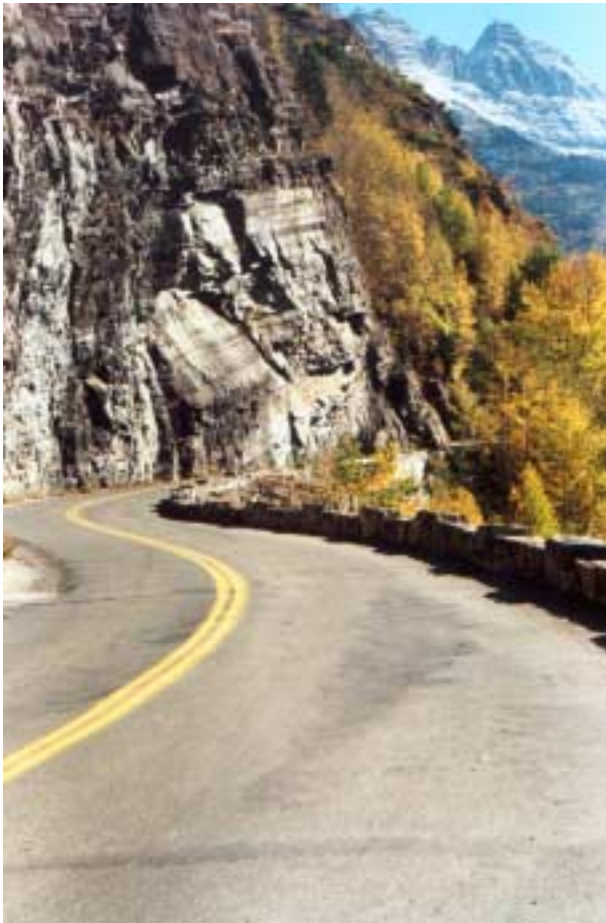
Rockfall hazard area

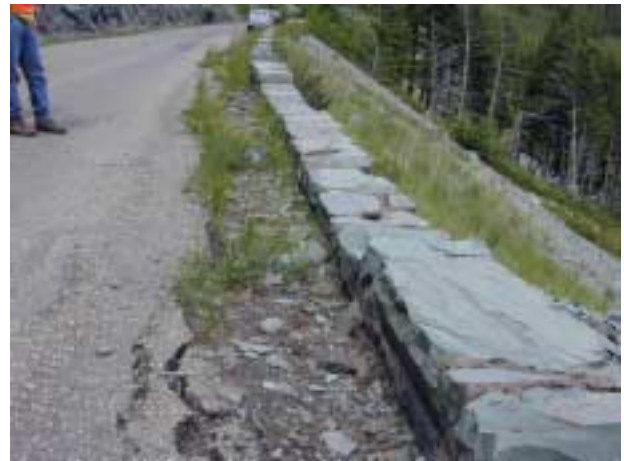
Inadequate guardwall height due to settling and successive pavement overlays

- In several locations, there is no barrier to prevent vehicle entry into roadside drainage inlets.
- Low guardwalls do not provide an adequate barrier for vehicles and pedestrians.
- Missing sections of protective guardwall.
- Poor drainage results in standing water or icing, which creates a hazard for motorists and cyclists.
- Large barrier rocks on the Road shoulder do not provide a continuous smooth transition through constricted areas, which presents a safety hazard for motorists.
- In some locations, deteriorating pavement such as cracks, potholes, and uneven or

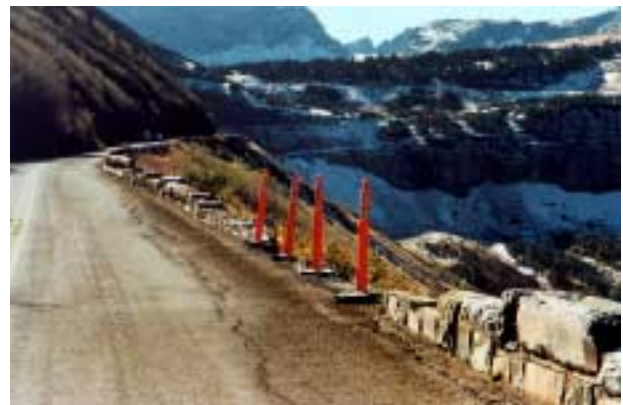
Damaged guardwall

removable timber rails, large barrier rocks, and temporary concrete barriers. Many of the historic stone masonry guardwalls are missing, leaning away from the Road, or have been displaced due to poor drainage, lack of adequate foundations, avalanche and snow weight pressures, vegetation and root damage, and in some cases insufficient maintenance practices. In some locations, guardwalls have settled and/or their height has been encroached upon by pavement overlays or patching that reduces their effectiveness as a safety barrier. Temporary concrete barriers (Jersey barriers) are used as an interim safety measure until historically appropriate barriers can be re-established.

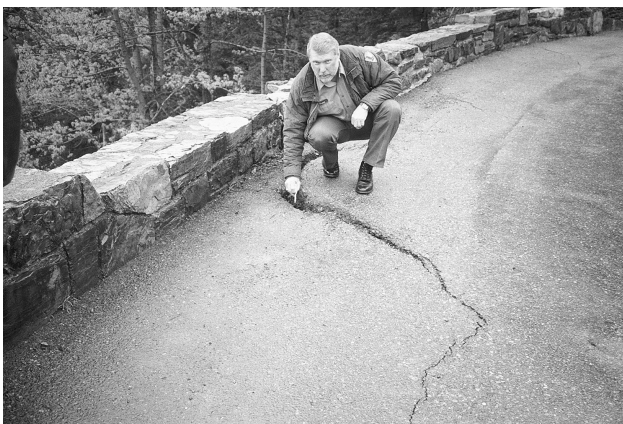
Pavement cracks

The original Road was not constructed to handle current traffic levels and vehicle weights. Water seeps into the roadbase, age, and traffic have all contributed to pavement deterioration. Excessive voids have occurred in base course material, with subsequent settling and failure of the roadway and shoulders. Various stages of road distress are present including potholes, cracks, ruts, erosion of shoulders, and sinking and raveling of the pavement's edge. Although many cracks have been filled and damaged areas patched, the underlying conditions that caused roadway damage have not

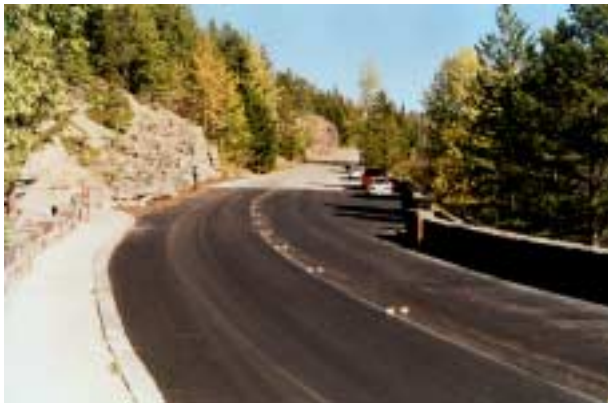
Baring Creek Bridge at Sunrift Gorge

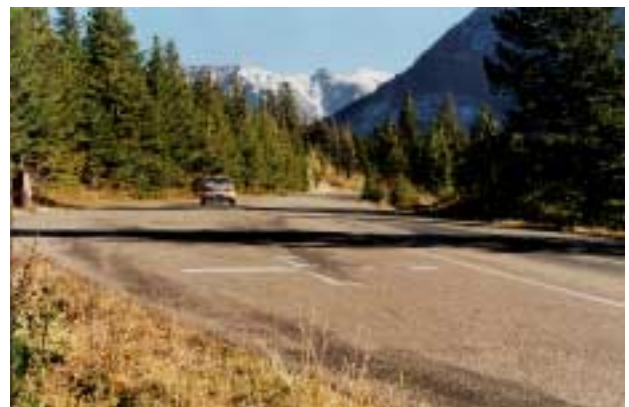
Wild Goose Island Overlook pullout

Wild Goose Island Overlook. Wild Goose Island on St. Mary Lake is one of the most photographed sites in GNP and is best seen from this overlook. Existing pullouts provide parking at two sites north of the Road and one site on the same side of the

Road as the overlook. Pedestrians using the north side pullouts must cross the road in an area with inadequate sight distance for safe crossing. Undefined parking spaces lead to inefficient use of space and congestion during peak times. The existing viewing area is not designed to accommodate the type of use and number of visitors at the site. In addition, the scenic views once available from this site have been obscured by vegetation growth.

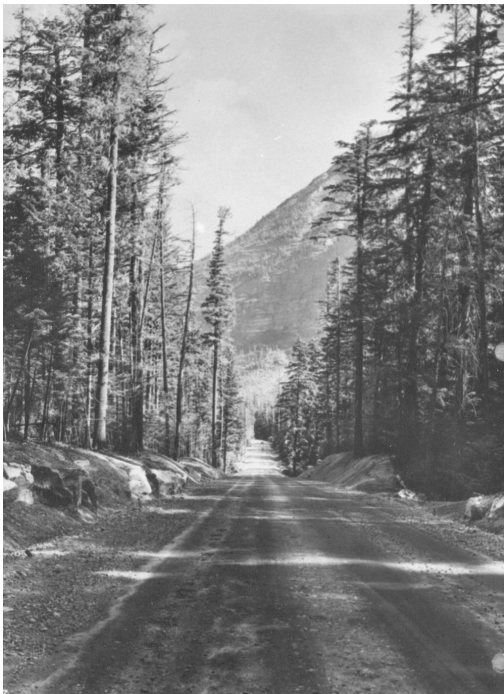
Figure 3. Roadside Vegetation in 1939 (left); Roadside Vegetation Near the Same Location in 1987 (right).

The Road provides exceptional scenic views of the landscape, which is the primary reason that most visitors drive the Road. Since the original Road construction, vegetation growth adjacent to the Road shoulder has blocked scenic vistas, diminishing the quality of the visitor experience the Road was intended to provide. As seen in Figure 3, vegetation growth along the Road has increased substantially since original construction because of the additional light and moisture available along the roadway margin. Scenic viewpoints such as The Loop, Jackson Glacier Overlook, Sun Point, along Lake McDonald and elsewhere no longer provide the scenic vistas originally intended along the Road.

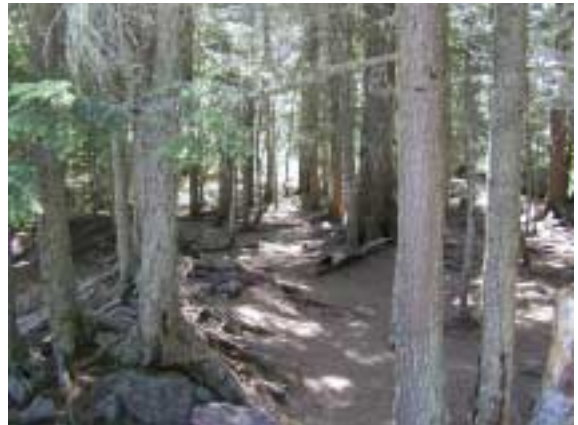
Social trail at Red Rock Point

Several of the pullouts and parking areas located along the Road provide trailhead access (Figure 4). Some trailheads lead to formally designated trails. In other locations, informal trails have been created by visitor travel to scenic overlooks or points of interest adjacent to the Road. The informal social trails created by visitors frequently result in multiple trails and resource damage to vegetation and soils.

congestion without major infrastructure improvements in parking and pullout capacity. Safety issues include poorly located or designed parking and pullouts that create a hazard for pedestrians and motorists. Another issue is resource damage caused by visitors from informal social trails and off-shoulder parking.
